# Condition of Tumut Hospital - 2006

This document prepared by "No more Bandaid Solutions Inc."  
October 2006

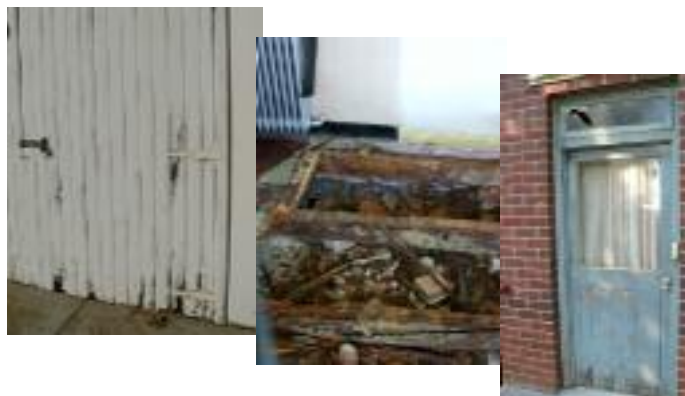
**Decay of Building Structures** Floorboards located in the main hospital building have collapsed recently as a result of significant rotting. Inspection following the collapse showed evidence of dry rot and copious unidentified white powdery and crystalline growth on the rotting wood. The affected area was adjacent to the 1898 structure and formed part of a conversion of an outdoor area, originally containing grass and large ferns, to an indoor area.

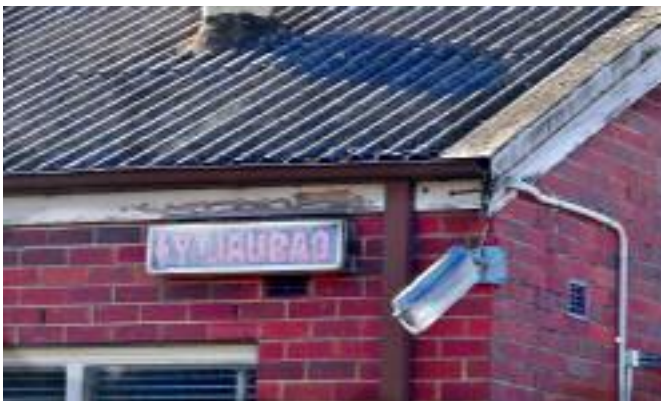
**Asbestos** is located in ceiling and wall cavities, in under floor areas and in roofing at Tumut Hospital.

Some rooves are made of decaying asbestos and generally not well maintained. PS This photo is printed the correct way round.

The entire roof of one building at the rear of the hospital is constructed of asbestos and is coated in dirt and lichen. Broken fibro can be seen in various locations.

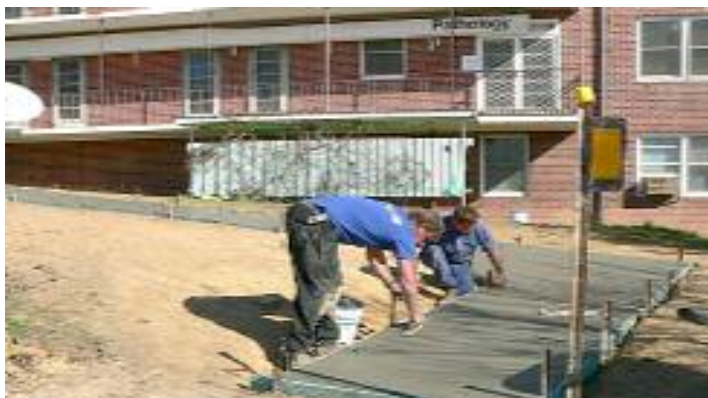
This pathway from the car park to Pathology has been needed for thirty years. Now it is the latest example of the "bandaid solutions" approach. Pathology is at the end of an undulating raised walkway in the old nurses home.
